METALS HANDBOOK

VOL. 9
FRACTOGRAPHY AND ATLAS OF FRACTOGRAPHY

8th EDITION

Fractography and Atlas of Fractographs

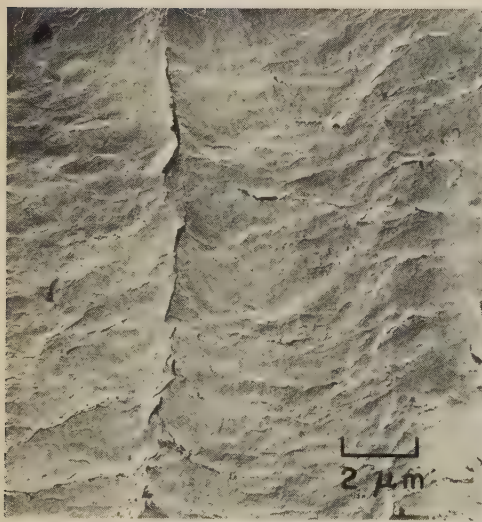
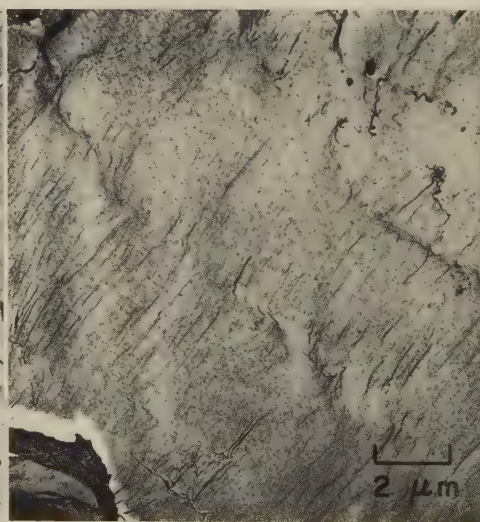
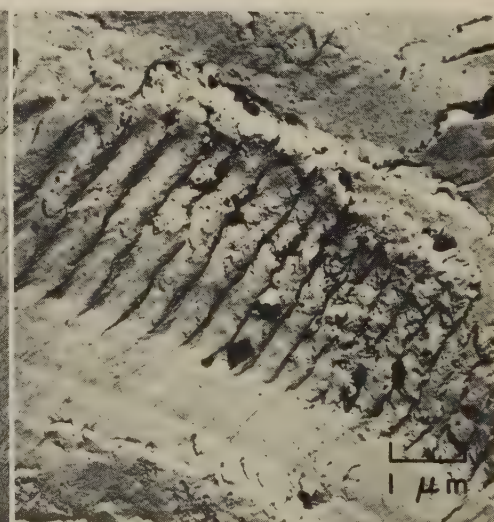
TEM fractograph (p-c replica) 5000× TEM fractograph (p-c replica) 5000× TEM fractograph (p-c replica) 10,000×
3602, 3603, 3604 Three transmission electron microscope views of the surface of the high-cycle fatigue fracture in 1020 steel shown in fractograph 3601 (above, right). Although they illustrate the same fracture as that in SEM fractograph 3601, fractographs 3602 (left) and 3603 (center) both show fatigue striations with considerably finer spacings. This demonstrates the excellent capability of the transmission electron microscope in resolving such low-relief, low-contrast features. In both 3602 and 3603, note the tear ridges between fatigue patches, a feature that is similar to that observed in fatigue fractures in aluminum alloys. Fractograph 3604 (right) illustrates "tire tracks", a fatigue-fracture characteristic that is more typical of aluminum alloys than of steel. The pattern of "tire tracks" extends diagonally from lower right to upper left; a rub mark lies below it.

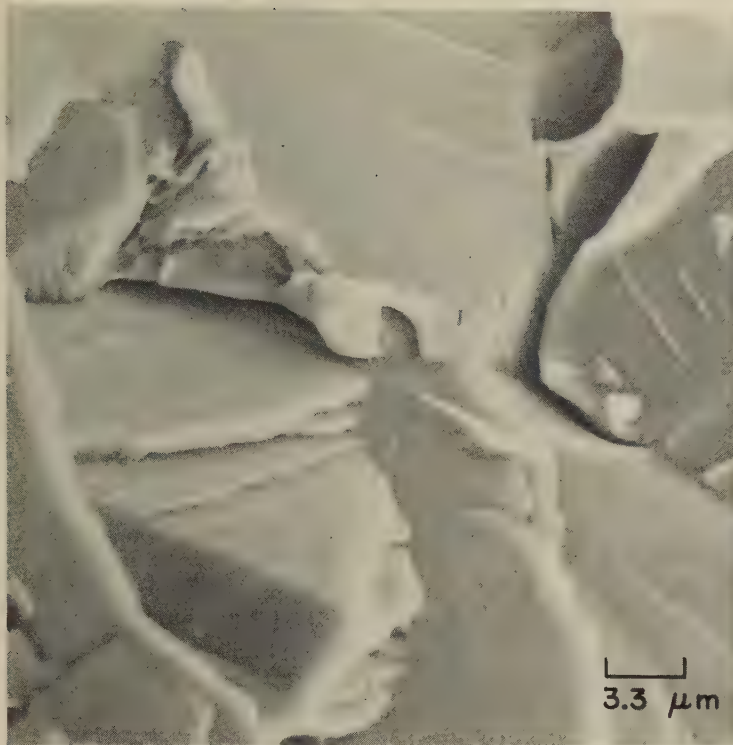
3605 Cleavage fracture in 1021 steel heat treated at 900°C (1652°F) for $\frac{1}{2}$ hr and air cooled. Ferrite-pearlite structure. Hardness, 120 dph. The specimen was notched, and was broken by impact at -196°C (-321°F). The cleavage occurred on various $\{100\}$ planes having different orientations. See fractographs 3606 to 3608.

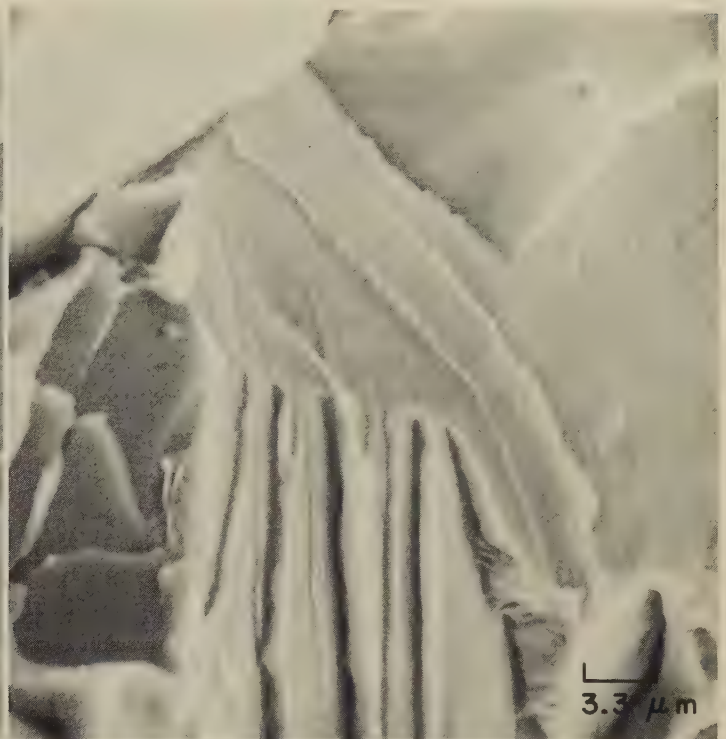
3606 Another SEM view of the fracture in 3605 (left), showing similar flat cleavage facets along crystallographic planes, but also showing very pronounced steps that form a gross example of a river pattern beginning at either a twist or a tilt boundary. See also fractographs 3607 and 3608.

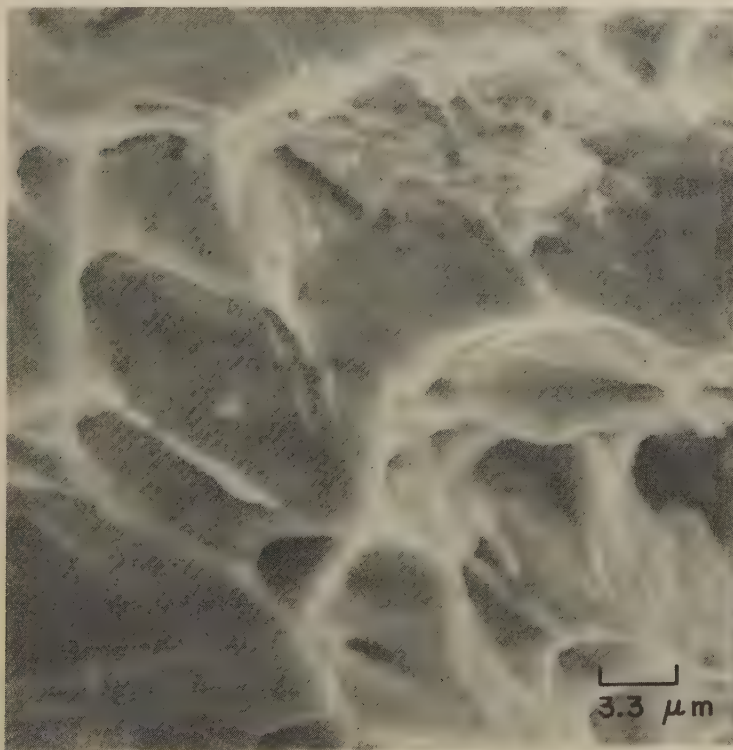
3607 Same steel (1021) and heat treatment as in fractographs 3605 and 3606, but a notched specimen broken by impact at 100°C (212°F). Ductile dimples are present in a wide variety of sizes, ranging from 1 to $10\text{ }\mu\text{m}$ in diameter. See also fractograph 3608.

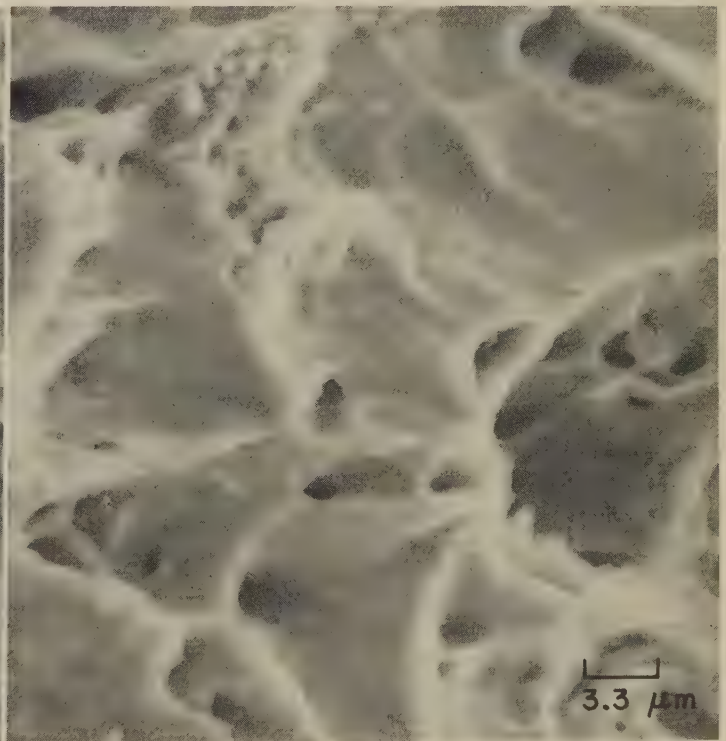
3608 Another view of the impact fracture shown in fractograph 3607 (at left). Again, dimples are seen in a wide range of sizes. Some dimples hold small intermetallic inclusions; others have smooth walls such as those of dimples produced by stretching.

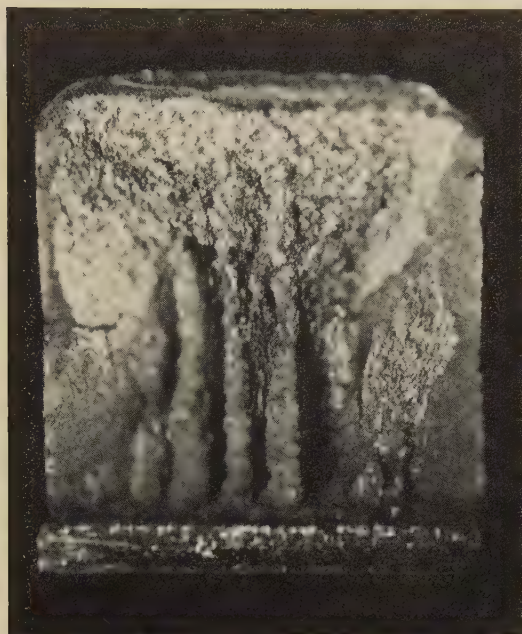
Light fractograph 6½×
3609 Impact fracture in Charpy specimen from 1022 steel strut cold formed from hot rolled round. Fracture propagated in a ductile manner from root of notch, converting to cleavage fracture near top. See 3610 to 3614.

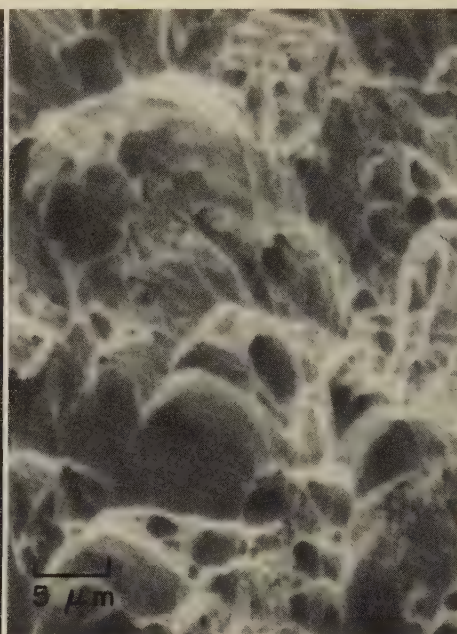
SEM fractograph 2000×
3610 Scanning view of ductile crack-initiation area of fracture in 3609. This region of the forging was well worked, and shows dimpled rupture. See 3612 and 3613.

Micrograph - nital 100×
3613 Higher-magnification view of the central region of the section in 3612, showing the thoroughly worked structure that yielded the ductile fracture shown in fractograph 3610 (above). See also micrograph 3614 (at right).

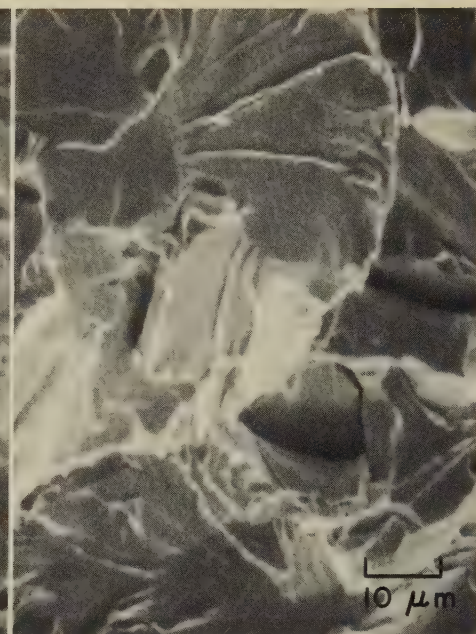
SEM fractograph 1000×
3611 Scanning view of the cleavage portion of the fracture shown in 3609. This region of the forging was lightly worked, as is shown in 3614 (below). See also 3612 and 3613.

Micrograph - nital 100×
3614 Higher-magnification view of one of the wedge-shaped end regions of the section in 3612, showing the equiaxed grain structure (coarser than the structure in 3613) that yielded the cleavage fracture shown in 3611 (above).

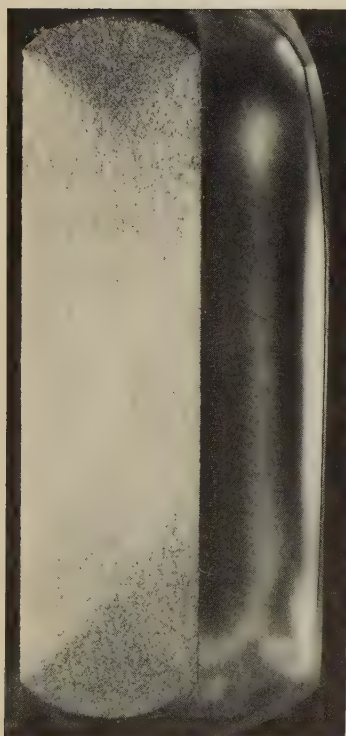
Macrograph - nital 2½×
3612 Polished cross section from the cold formed strut shown in 3609 (above). Note the light working of the wedge-shaped end regions.

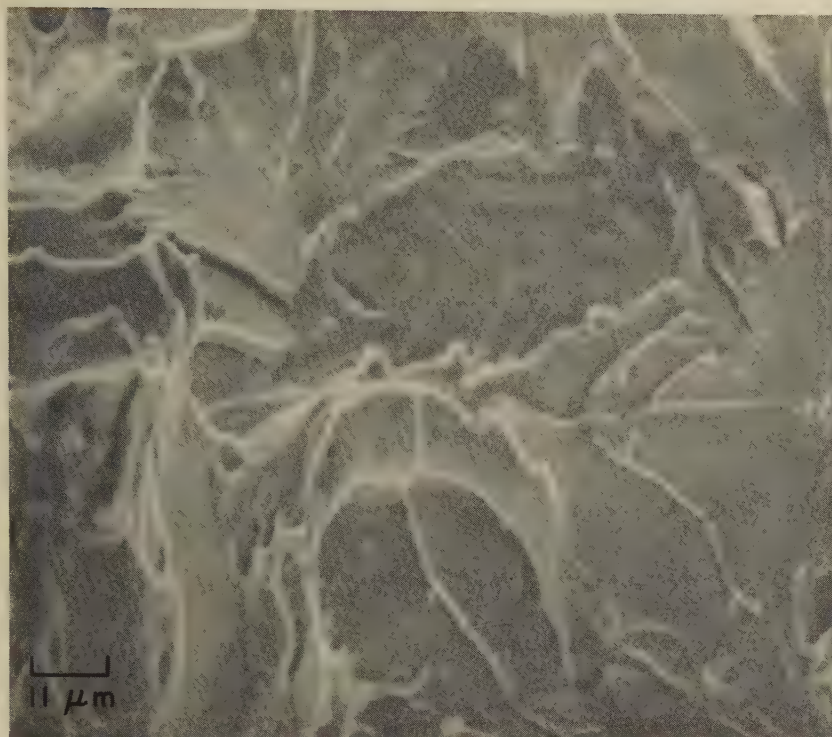
SEM fractograph 900×
3615 Charpy impact fracture in specimen taken from 1022 steel vehicle-arm forging. The part had been heat treated to a hardness of Rockwell B 70.5. Impact was at -9°C ($+16^{\circ}\text{F}$), which is below the transition temperature for this material. Fracture mechanism was brittle cleavage; there is no evidence of dimples.

SEM fractograph 565×
3616 Room-temperature Charpy impact fracture in a specimen of 1025 steel. Unlike that in 3615, this specimen shows two mechanisms of fracture—namely microvoid coalescence at the top and cleavage below. Note the pronounced steps.

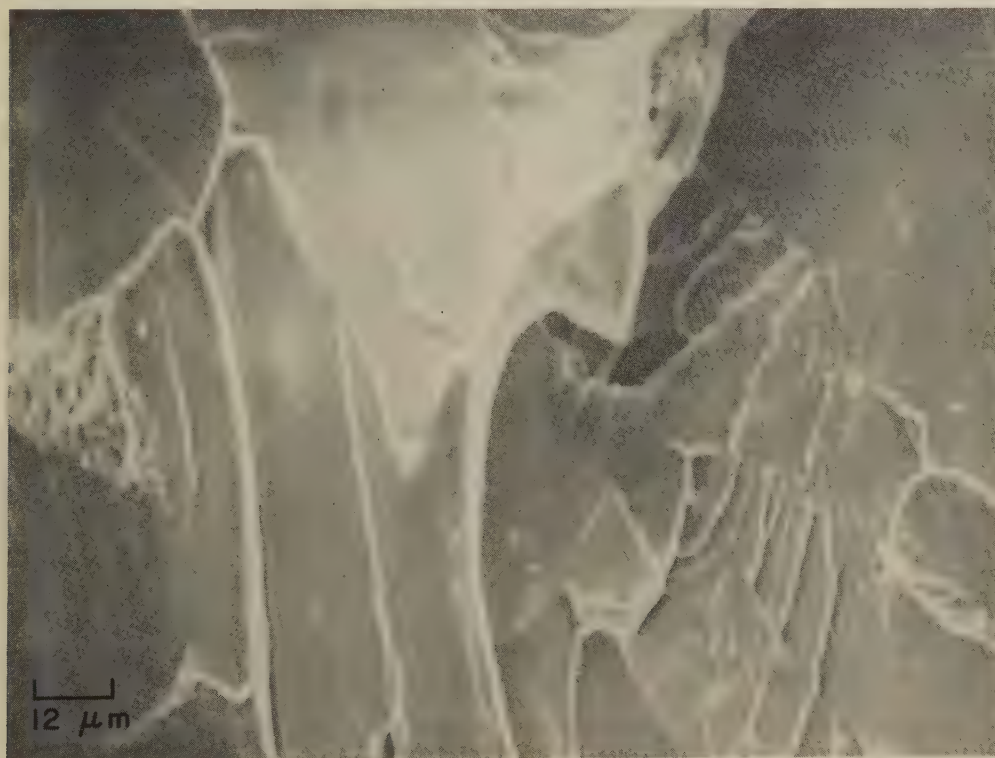
SEM fractograph 850×
3617 Tension-overload fracture in a specimen taken from a latch-arm forging of ASTM A36 steel. The forging had been normalized; the tension test was performed at room temperature. Most of the fracture-surface facets have been identified as cleavage, but there is some evidence of dimples—particularly at left center. Note the abrupt changes in river patterns. See also micrograph 3618 (at right).

Micrograph—10% nital 150×
3618 Section of the ASTM A36 steel test specimen in 3617 (left), showing ferrite-pearlite microstructure. Tensile properties of the steel were below specifications.

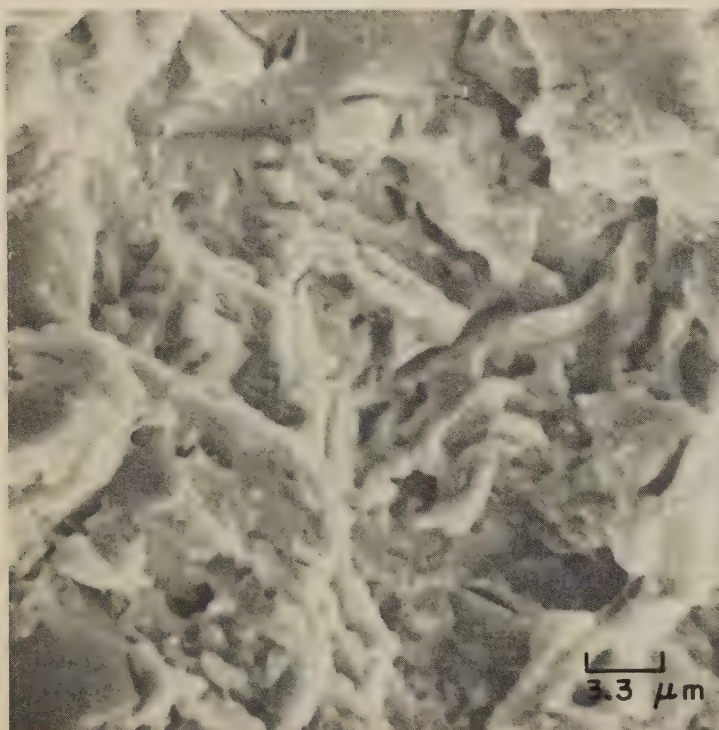
SEM fractograph 3000×
3619 Water quenched. Structure, slightly tempered martensite. Hardness, 660 dph. Fractured by impact at -196°C (-321°F) with an impact energy of 0.1 kgm/cm^2 . Complex cleavage steps about a few intergranular facets.

The SEM fractographs above, and those on the facing page, show the surfaces of impact fractures obtained in specimens of 1042 steel (0.45% C, 0.62% Mn, 0.27% Si) that had been heat treated $\frac{1}{2}$ hr at 850°C (1562°F).

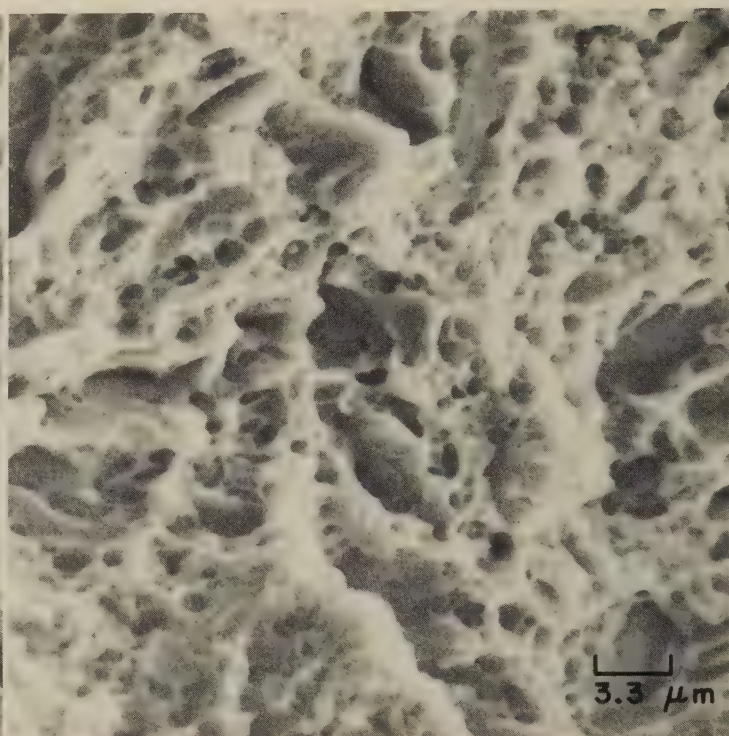
SEM fractograph 3000×
3620 Same as fractograph 3619 (at left), but this specimen was fractured by impact at 100°C (212°F) with an energy of 0.2 kgm/cm^2 . Note that this fracture has occurred almost completely by microvoid coalescence.

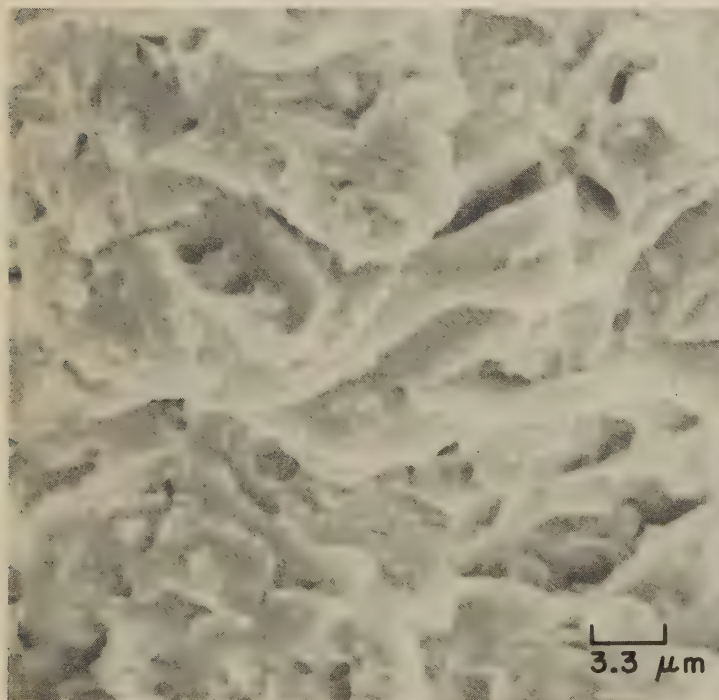
SEM fractograph 3000×
3621 Water quenched, and tempered for 1 hr at 500°C (932°F), giving a hardness of 335 dph. The specimen was then fractured by impact at -196°C (-321°F) with an energy of 1.4 kgm/cm^2 . Complex array of transgranular cleavage steps with several suggestions of small dimples.

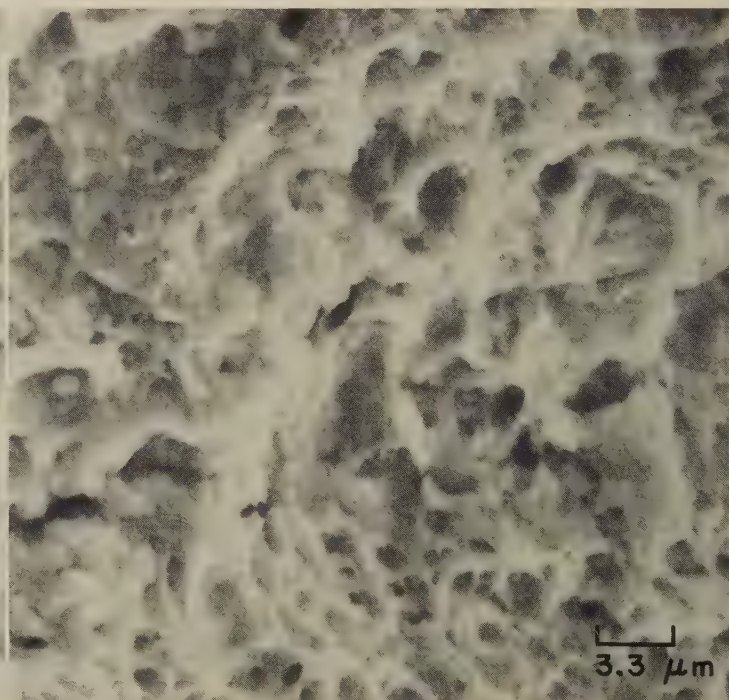
SEM fractograph 3000×
3622 Same as fractograph 3621 (at left), but fractured by impact at 100°C (212°F) with an impact energy of 8.8 kgm/cm^2 . This fracture surface shows much more flow than does the surface of the fracture shown in 3620 (above). Several of the dimples have been appreciably elongated.

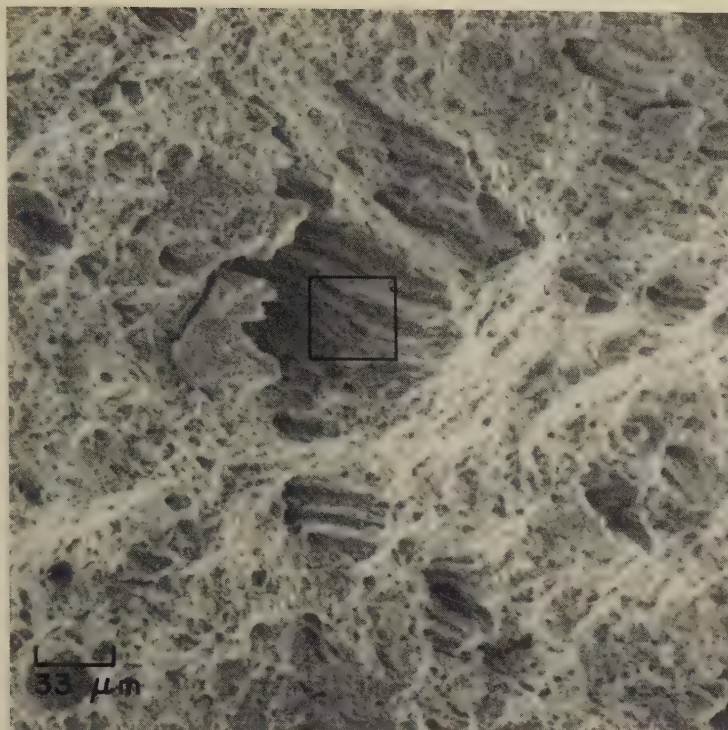
SEM fractograph 300×
3623 Same as 3622 (facing page), but at lower magnification. The dimpled rupture shows secondary cracks with stringer-type characteristics probably reflecting the orientation of the original rolling direction. See 3624 for enlargement of area in square.

The SEM fractographs above, and those on the facing page, show the surfaces of impact fractures obtained in specimens of 1042 steel (0.45% C, 0.62% Mn, 0.27% Si) that had been heat treated ½ hr at 850 C (1562 F).

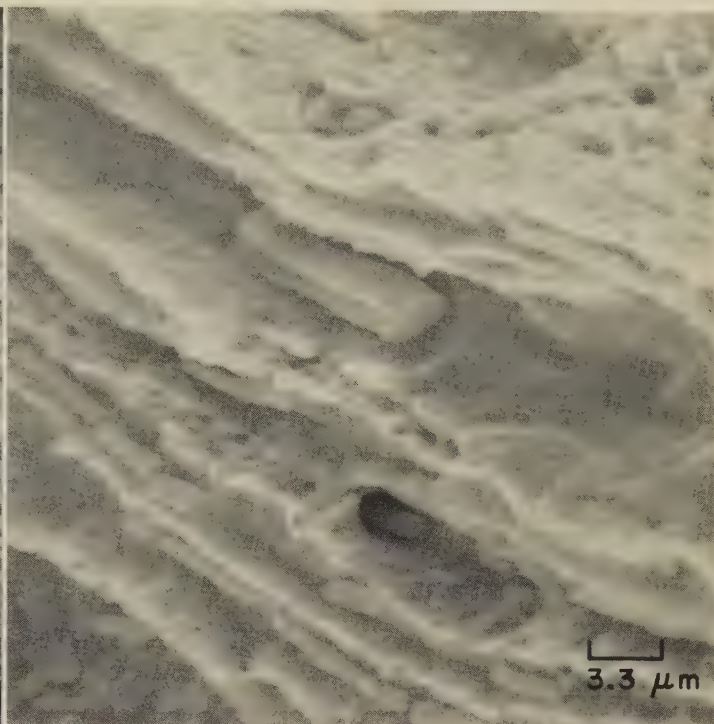
SEM fractograph 3000×
3624 Higher-magnification view of the area within the square at center of fractograph 3623 (at left), showing more clearly the details of the inclusion stringers that were aligned by the rolling process. Local segregation of nonmetallic inclusions is indicated.

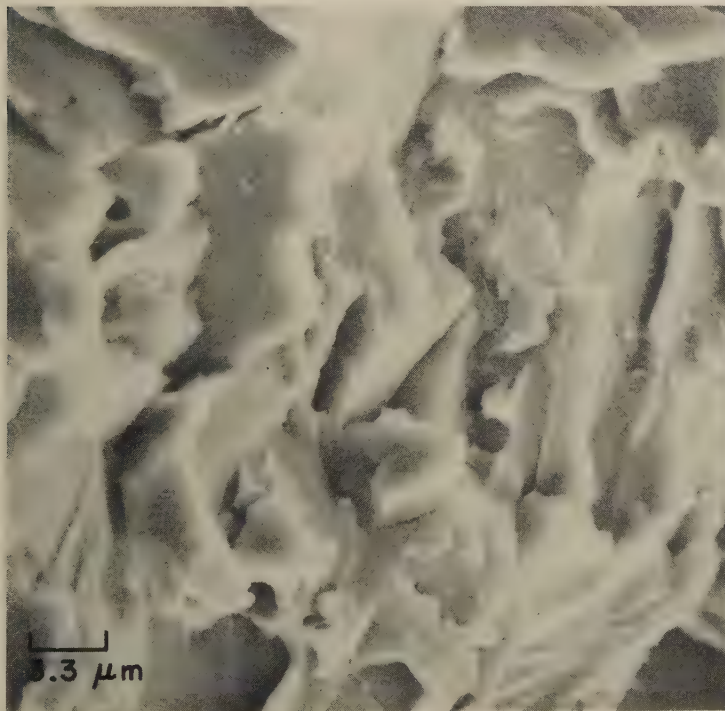
SEM fractograph 3000×
3625 After the ½-hr heat treatment at 850 C (1562 F), this specimen was air cooled. Hardness, 199 dph. The specimen was then broken by impact at -196 C (-321 F). The transgranular cleavage shows fine river patterns.

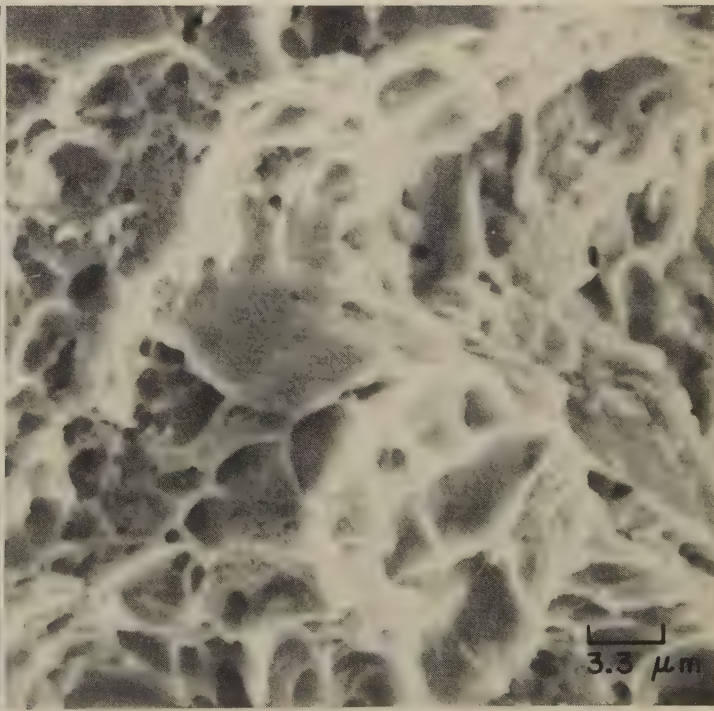
SEM fractograph 3000×
3626 Same as 3625 (left), but broken by impact at 100 C (212 F). As expected at this higher temperature, many of the dimples are highly elongated; several show a smoothness suggestive of the beginnings of stretching.

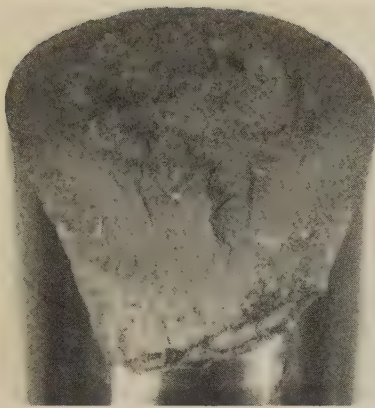
Light fractograph 1.5×
3627 Surface of an impact fracture in a 1050 steel automotive rear axle. The perimeter is fine grained; the core is fibrous. Note spill area. See 3628-3634.

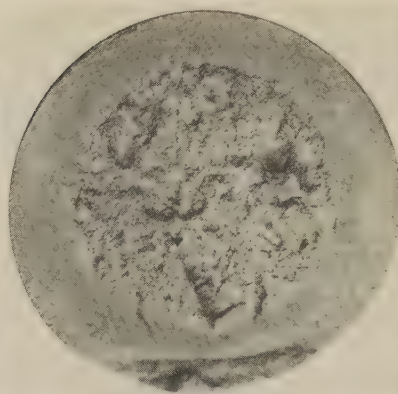
Light fractograph 1.5×
3628 End view of the fracture shown in 3627. Fine chevron marks are visible in the perimeter and point to the origin of the fracture (at top).

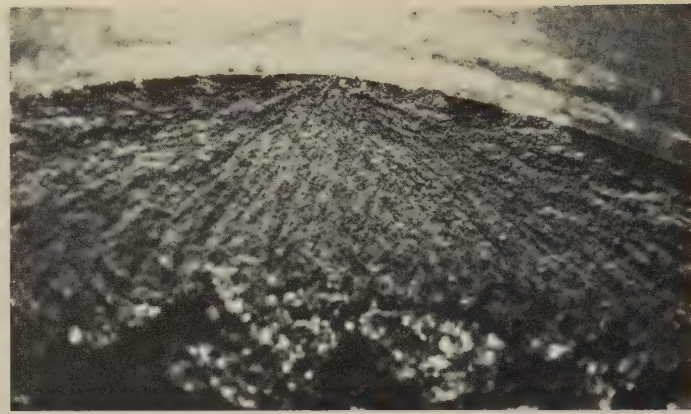
Light fractograph 4×
3629 Higher-magnification view of fracture origin in 3628, showing more clearly the chevron marks radiating from the crack nucleus at the edge at top center. Note poorly contoured fillet on axle surface immediately adjacent to fracture origin. See 3630 to 3632.

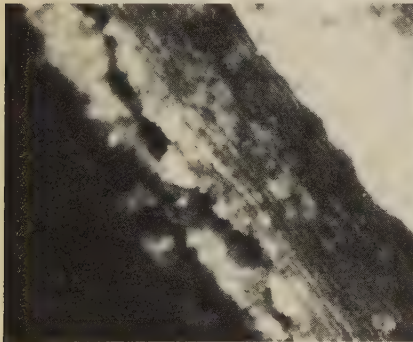
Light fractograph 30×
3630 A still more highly magnified view of the fillet and edge of the crack origin shown in 3629. Note the rough machining marks in the fillet.

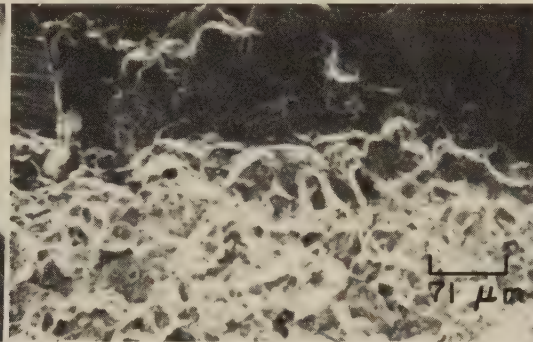
SEM fractograph 140×
3631 Oblique view of the fracture-origin area in 3628 to 3630, showing the tool marks in the fillet above and the overload-tension dimples below. No evidence of harmful inclusions was found in subsequent sectioning.

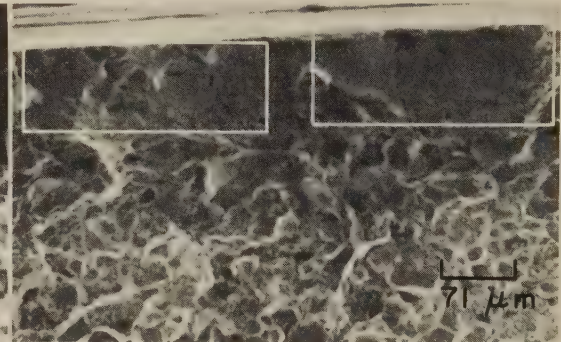
SEM fractograph 140×
3632 Same area as shown in fractograph 3631, but viewed from a different angle. The area of the crack origin (see 3633, 3634) lies in the fracture surface where it intersects the fillet surface (at top).

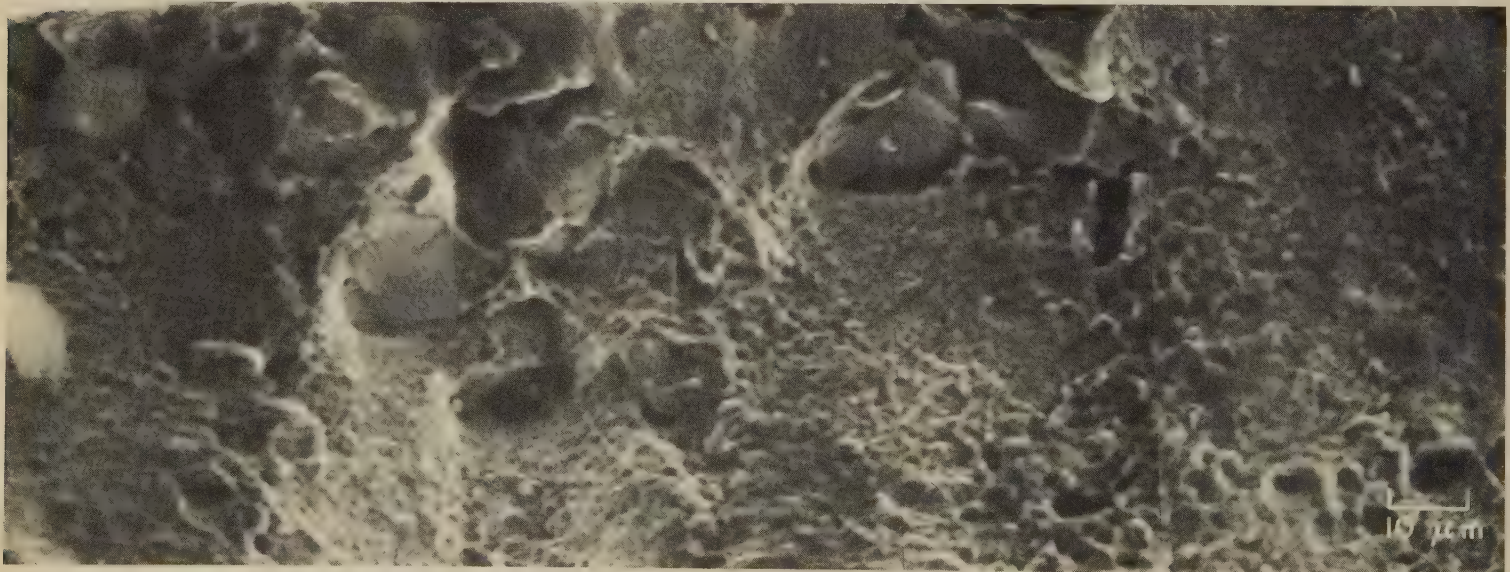
SEM fractograph (composite) 1000×
3633 Composite of four SEM views of the fracture-origin area shown in fractograph 3632, covering approximately one-half of the region visible in 3632 (left edge to center). It is evident that the first shallow penetrations of the crack were by stage I of fatigue-fracture progress and thus generated no fatigue striations. Penetration of the crack shortly transformed to advance by microvoid coalescence under impact. Note that the dimples visible here are exceedingly fine. The remainder of the fracture-origin area visible in fractograph 3632 (right edge to center) is shown as another composite in fractograph 3634 (top of facing page).

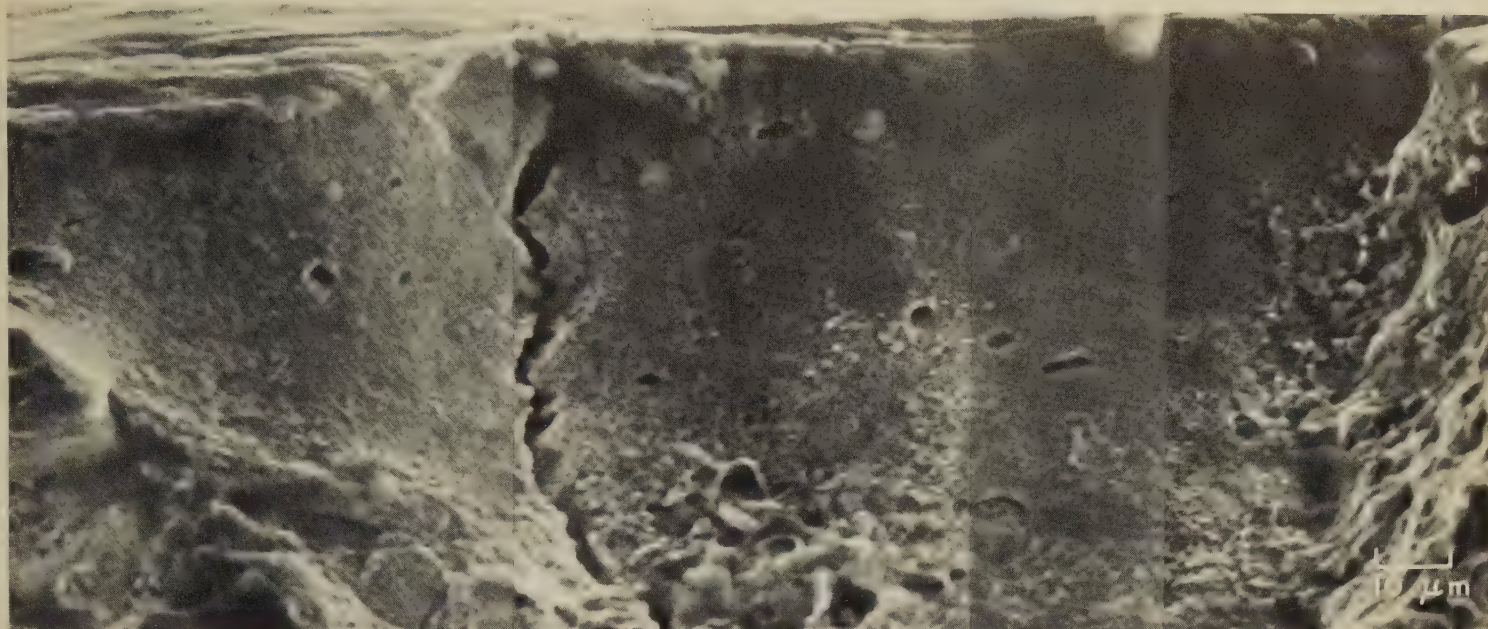
3634 Composite of four SEM views of the fracture-origin area shown in fractograph 3632, encompassing approximately one-half of that area (right edge to center). This composite completes a scan that was begun in 3633 (bottom row on facing page). Note the secondary crack, which is normal to the fillet and to the fracture surface, and which never grew beyond approximately 0.08 mm in length. Barely visible to the right is a transition to a dimpled overload type of rupture. No traces of fatigue striations are visible in the fatigue area, which (as in fractograph 3633) is consistent with stage I of fatigue-fracture progress.

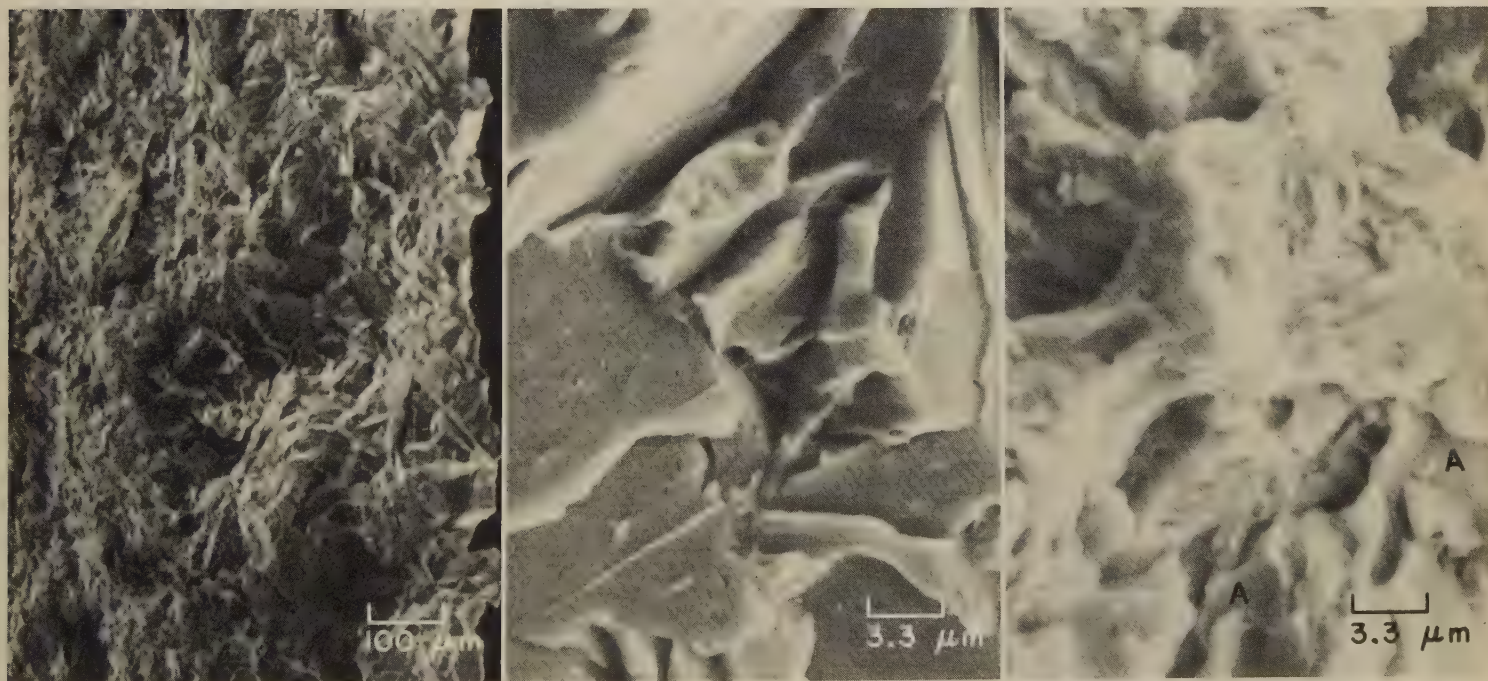
3635 Surface of impact fracture obtained at -196°C (-321°F) in modified 1060 steel (1.7% Si) decarburized 2 hr at 1075°C (1967°F), cooled to 850°C (1562°F), and oil quenched. Depth of decarburization, 0.30 mm. See 3636, 3637.

3636 Higher-magnification view of the decarburized zone (at right) in the specimen shown in fractograph 3635, showing that in this zone fracture was of the cleavage type. Note the feathery fine river patterns at top. See also 3637.

3637 Higher-magnification view of region below decarburized zone in 3635. In this region, the fracture appears to have progressed by more than one mechanism; small cleavage facets (marked A) and suggestions of small dimples both can be seen.

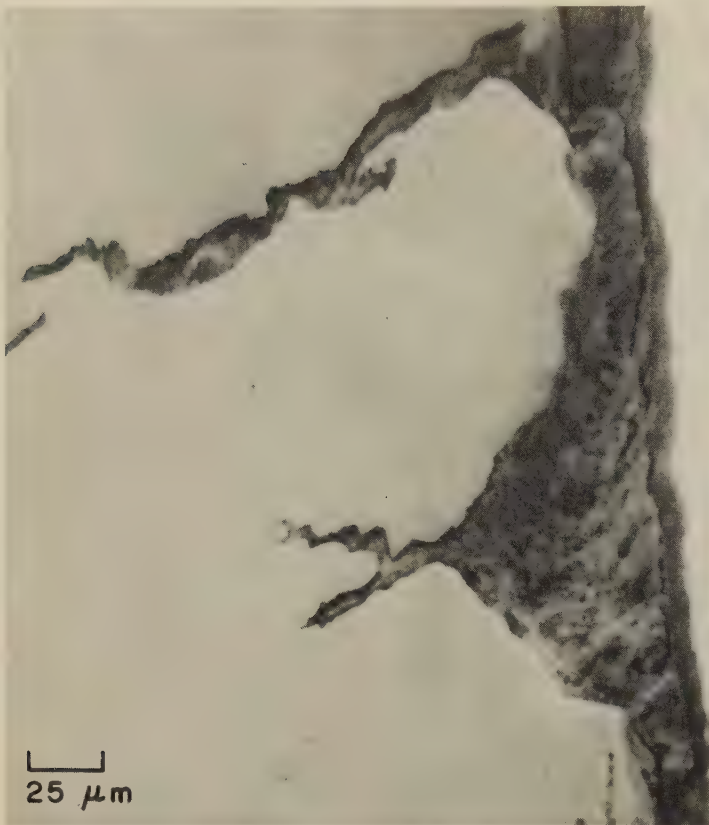
3638 Polished longitudinal section through a cold drawn wire (from a wire rope) of 1080 steel, showing corrosion pits, in the wire surface (right), from which stress-corrosion cracks have grown. Final rupture was by fast fracture (see 3639).

3639 Final fracture surface of the 1080 steel wire in 3638. The fracture began as stress-corrosion cracking (see 3638) and terminated in fast fracture. This view shows a region of fast fracture that consists generally of dimples.

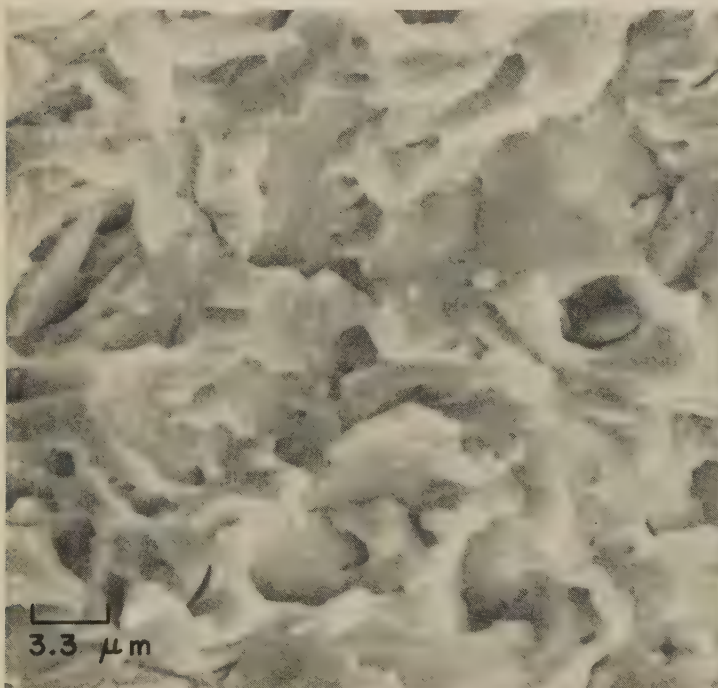
3640 Specimen of 1090 steel austenitized at 850°C (1562°F) $\frac{1}{2}$ hr, salt quenched to 280°C (536°F), held 1 hr, water cooled. Hardness, 602 dph. Microstructure, bainite and fine pearlite. Broken by impact at -196°C (-321°F). Complicated system of cleavage facets and steps. See also fractograph 3641.

3641 Another specimen of 1090 steel, given the same heat treatment as described in 3640 (left), but broken by impact at 100°C (212°F). A large portion of the fracture surface is composed of small dimples. See fractographs 3642 to 3652, on the next three pages.

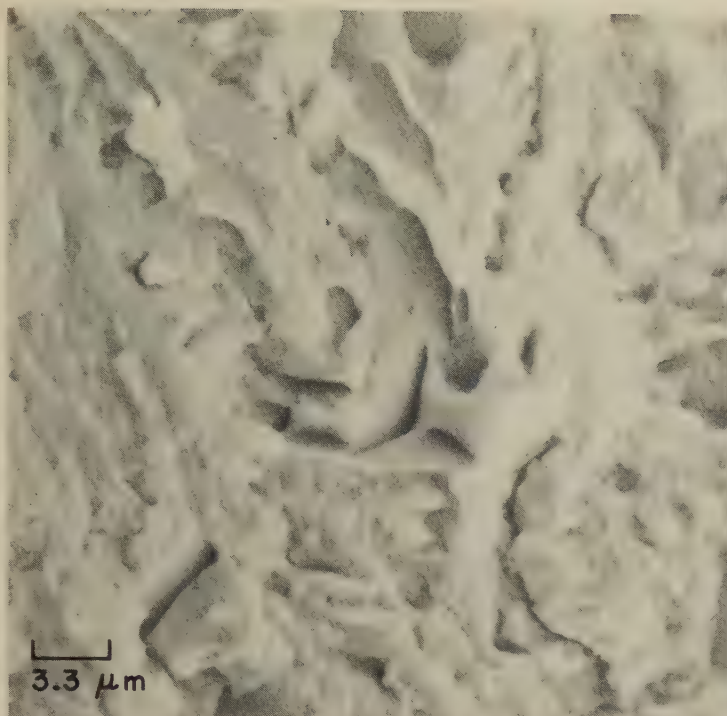
SEM fractograph 3000×
3642 Fracture in 1090 steel heat treated ½ hr at 850 C (1562 F), and air cooled. Hardness, 697 dph. Structure, martensite. This specimen was fractured by impact at -196 C (-321 F), producing a complex-cleavage fracture surface. Small secondary cracks are evident. See also 3643.

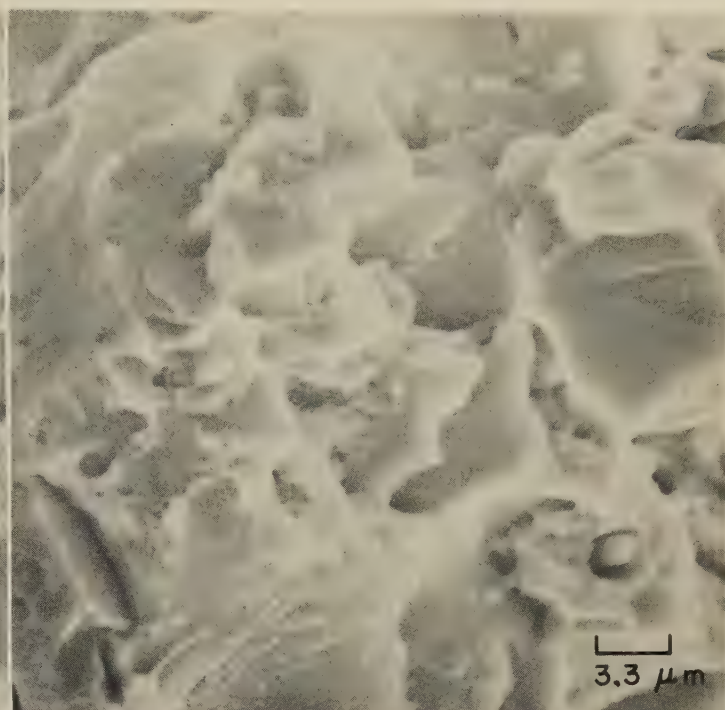
SEM fractograph 3000×
3643 Same steel and same heat treatment as in fractograph 3642 (left), but fractured by impact at 100 C (212 F). Cleavage facets are the dominant feature here, but a few small dimples can be seen also; one of them is located at lower right and contains an inclusion.

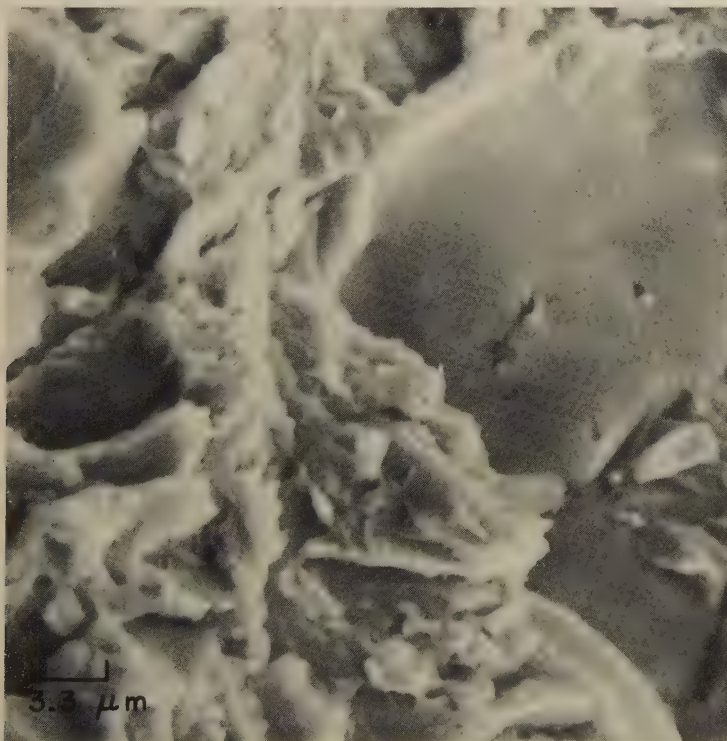
SEM fractograph 3000×
3644 Fracture in 1090 steel heat treated ½ hr at 850 C (1562 F), oil quenched, tempered 1 hr at 400 C (752 F). Hardness, 501 dph. Specimen was broken by impact at -196 C (-321 F). Intricate-cleavage areas interspersed with broad facets of intergranular fracture. See 3645.

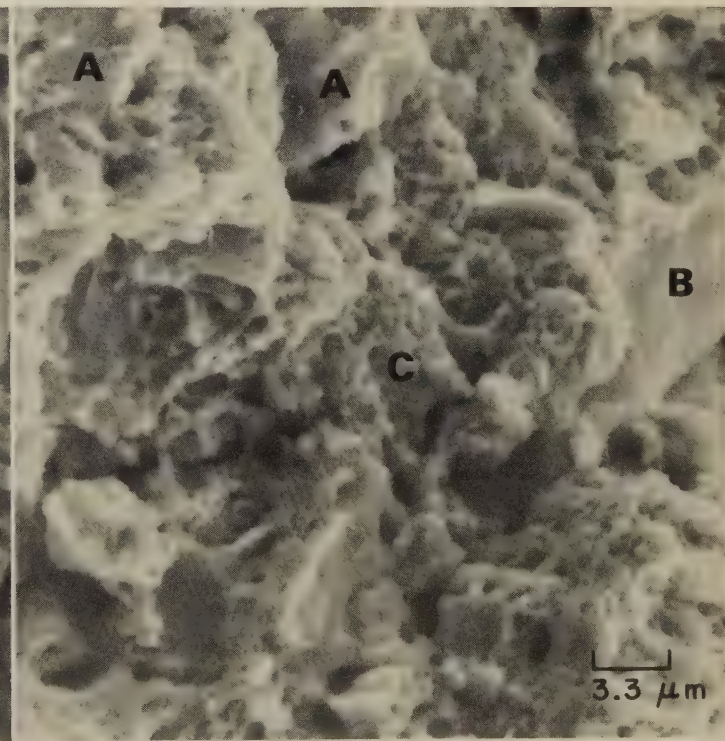
SEM fractograph 3000×
3645 Same steel and same heat treatment as in 3644 (left), but broken by impact at 100 C (212 F). This fracture surface contains a few cleavage facets (A) and shows evidence of some grain-boundary rupture (B), but mostly it consists of a general array of very fine dimples (C).

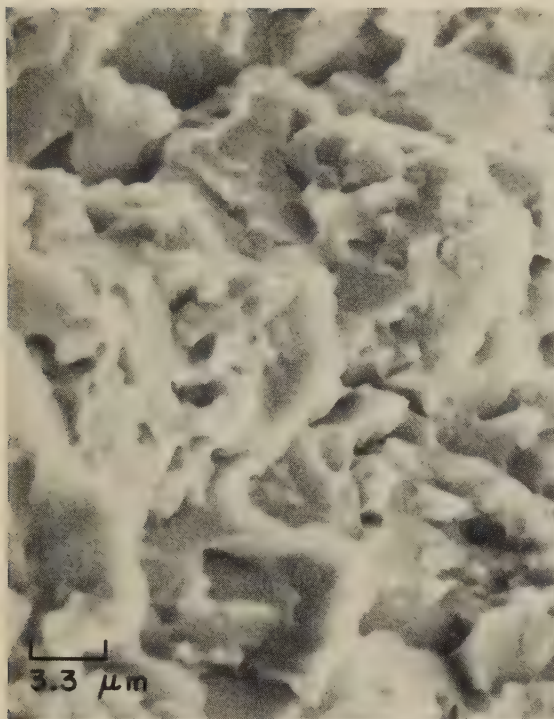
3646 Fracture in 1090 steel heat treated ½ hr at 850 C (1562 F), oil quenched, tempered 20 hr at 715 C (1319 F), air cooled. Microstructure, spheroidized carbide. Hardness, 189 dph. Impact was at -196 C (-321 F). Impact energy, 0.3 kgm/cm². Uniform, petal-like cleavage steps. See also fractographs 3647 and 3648, at right.

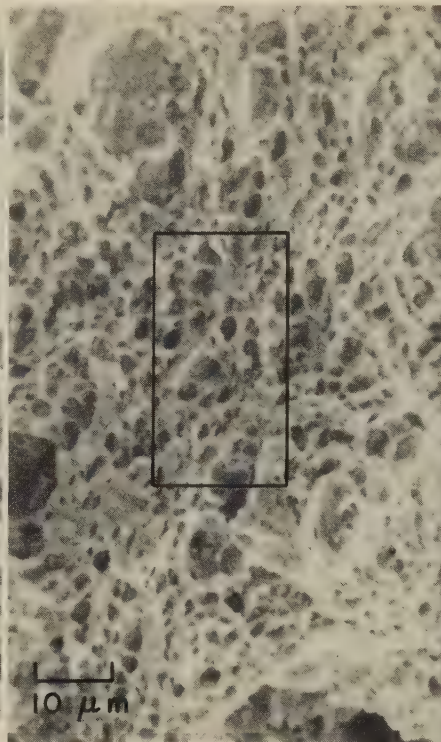
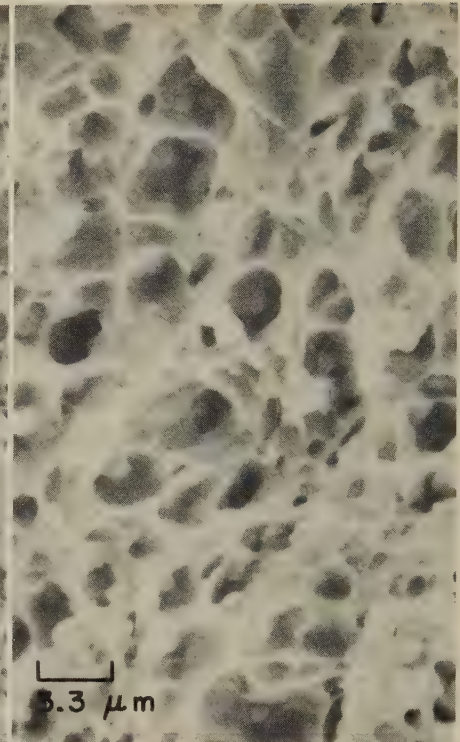
3647, 3648

Two SEM fractographs, at two different magnifications, showing a fracture in a specimen of the same steel as in 3646 (at left). This specimen received the same heat treatment as that described in 3646, but was fractured by impact at 100 C (212 F). Impact energy was 17.1 kgm/cm². A finely dimpled structure. The rectangle in fractograph 3647 (left) indicates the area shown at higher magnification in fractograph 3648 (right).

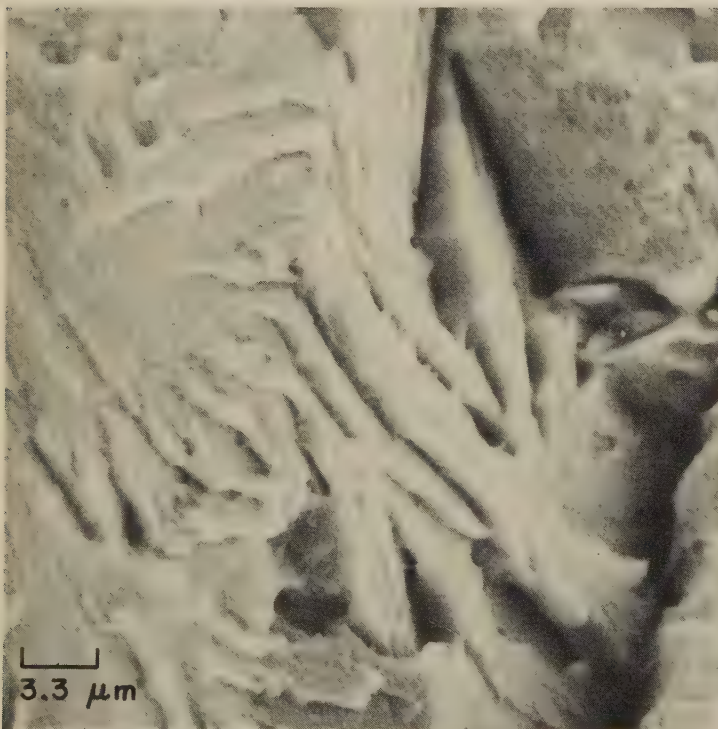
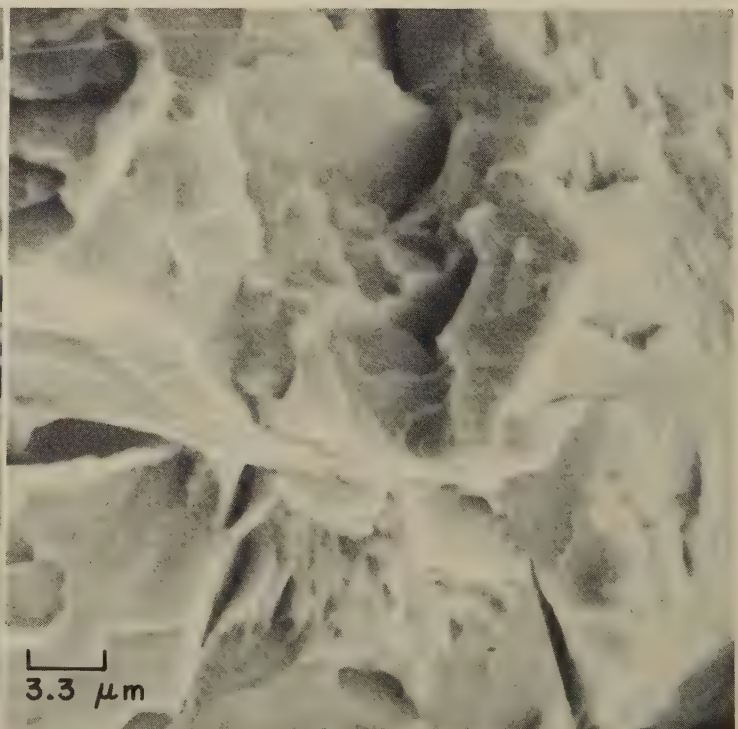
3649, 3650

Two SEM fractographs showing different regions of a fracture in 1090 steel that was heat treated ½ hr at 850 C (1562 F) and air cooled (same as 3642). Microstructure is pearlite. Hardness, 300 dph. The specimen was fractured by impact at -196 C (-321 F). The fracture surface consists of cleavage facets. In fractograph 3649 (left), the orientation of the pearlite lamellae with the fracture surface allows the pronounced secondary cracking to be seen. In the area shown in fractograph 3650 (right), the presence of the lamellae has influenced crack propagation, producing cleavage steps. See also 3651 and 3652.
